# REPORT OF APOLLO 204 REVIEW BOARD

TO  
THE ADMINISTRATOR  
NATIONAL AERONAUTICS AND SPACE ADMINISTRATION

Spacecraft 012 was undergoing a "Plugs Out Integrated Test" at the time of the accident on January 27, 1967. Operational Checkout Procedure, designated OCP FO-K-0021-1 applied to this test. Within this report this procedure is often referred to as OCP-0021.

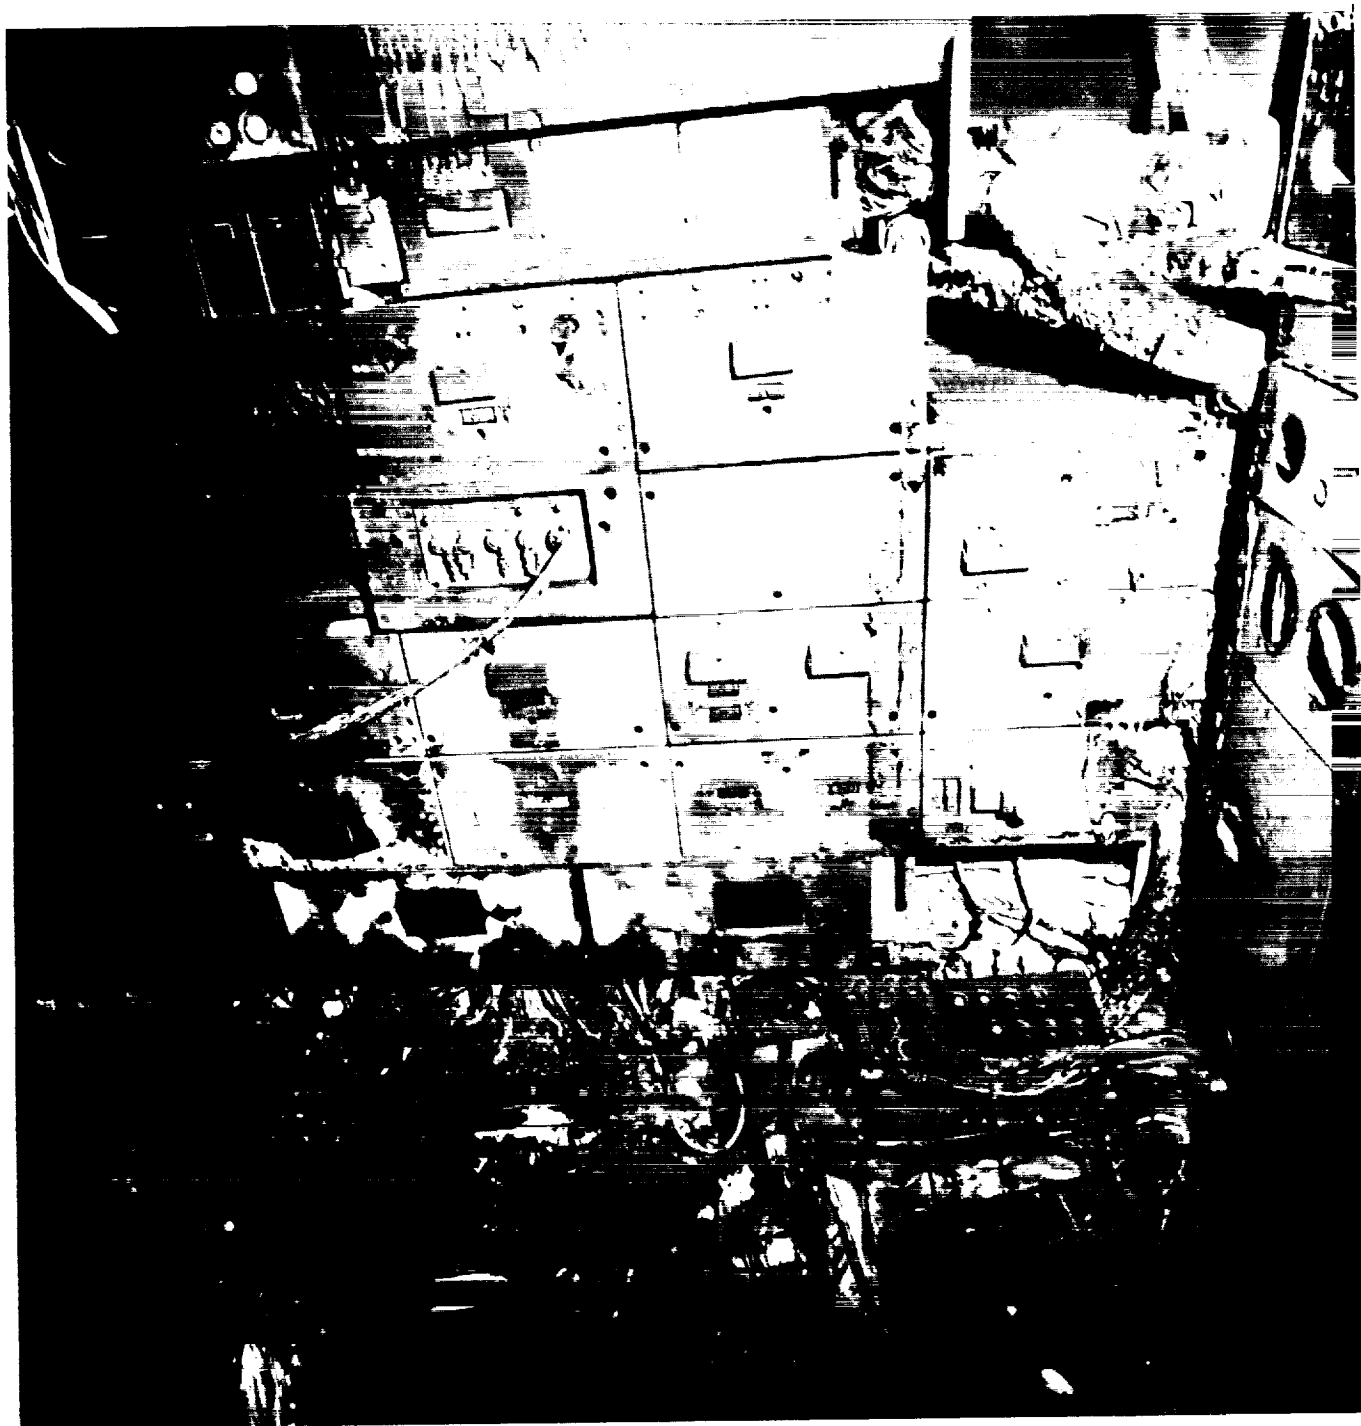
ENCLOSURE V-4

RIGHT HAND SECTION OF LOWER EQUIPMENT BAY

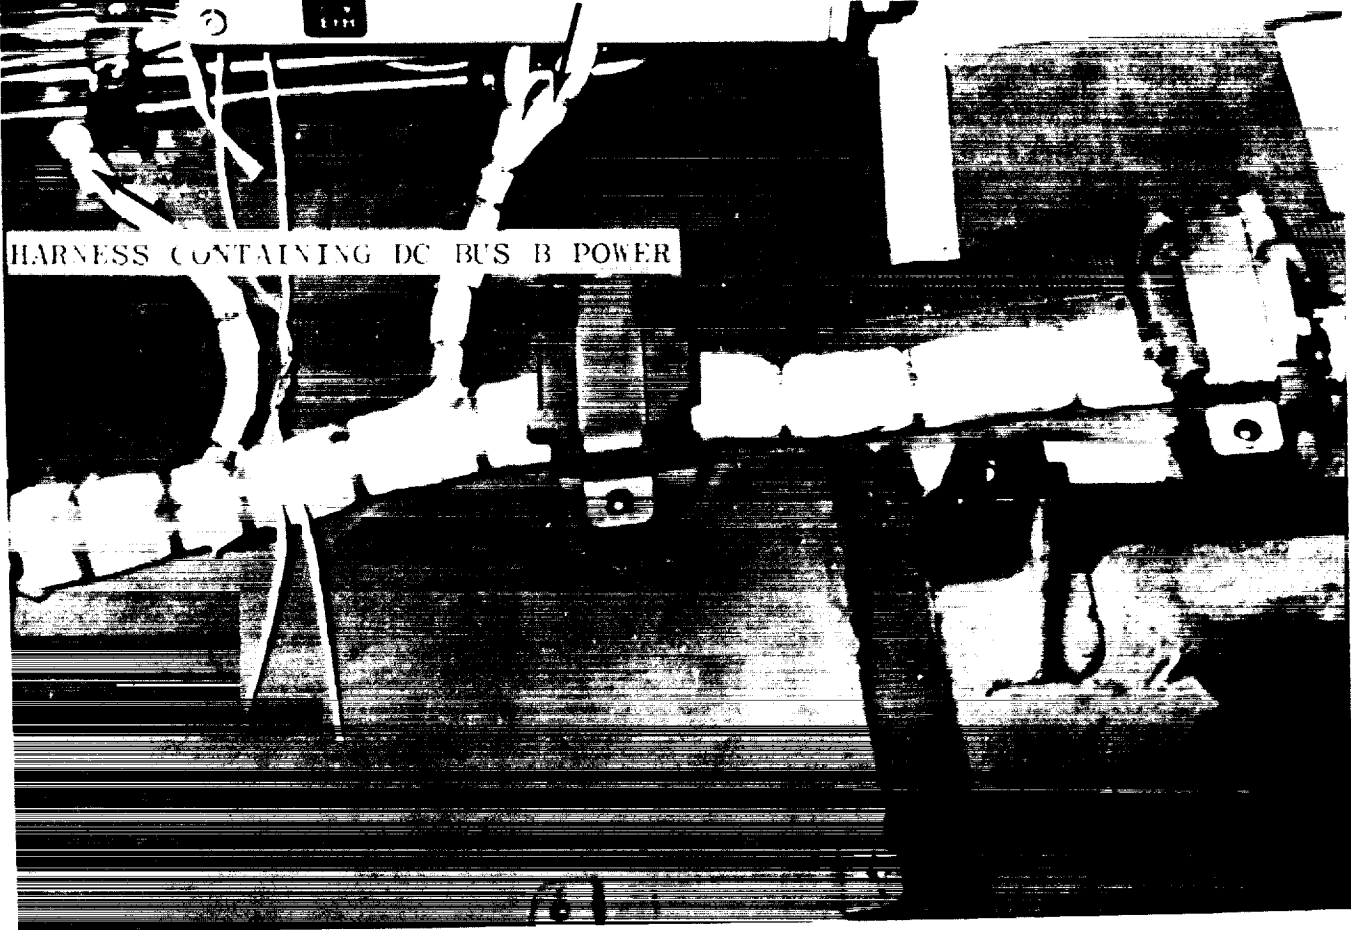
- V - 28      Photograph - View of Wire Bundle in Command Module 014 Containing DC Power Leads Passing Over Tubing and Entering Environmental Control Unit. A Similar Arrangement Existed in Command Module 012.

HARNESS CONTAINING DC BUS A AND B POWER

HARNESS CONTAINING DC BUS B POWER
